PGE Vegetation Management:

- Program Overview
- Risk Outline
- **Case Study:** Deploying Technology in an Evolving Wildfire Landscape

PGE & USFS collaboration with PGE's AWRR Vegetation Management Program

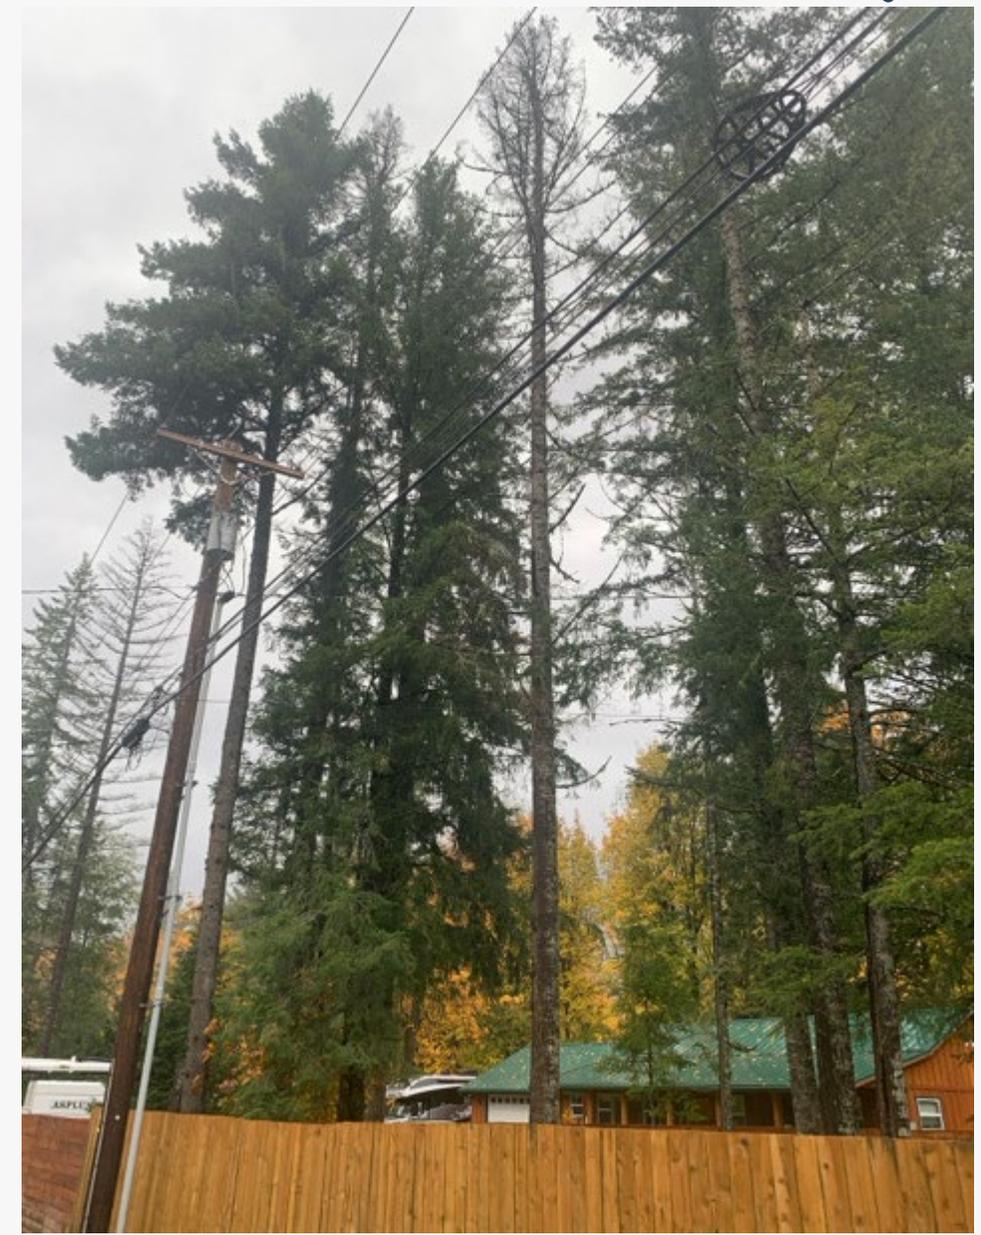
AWRR Work: C2- Remove (Work Complete)

Year	
Work Boundary	HFRZ
Work Type	Remove
Status	Work Complete
Condition Level	C2
Equipment	55
Species	Douglas Fir
Size - DBH	12-23.9
Debris Management	Chip
Forester Last Name	Donovan
Forester Comment	Dead; in corner of yard next road
Foreman Last Name	Cole
Crew Completion Date	November 6, 2023
Hours	
Crew Completion Comment	
Customer Notification	In-Person
Date of Customer Contact	
Customer Address	64601 Brightwood Loop
FollowUp Needed	
FollowUp Note	No

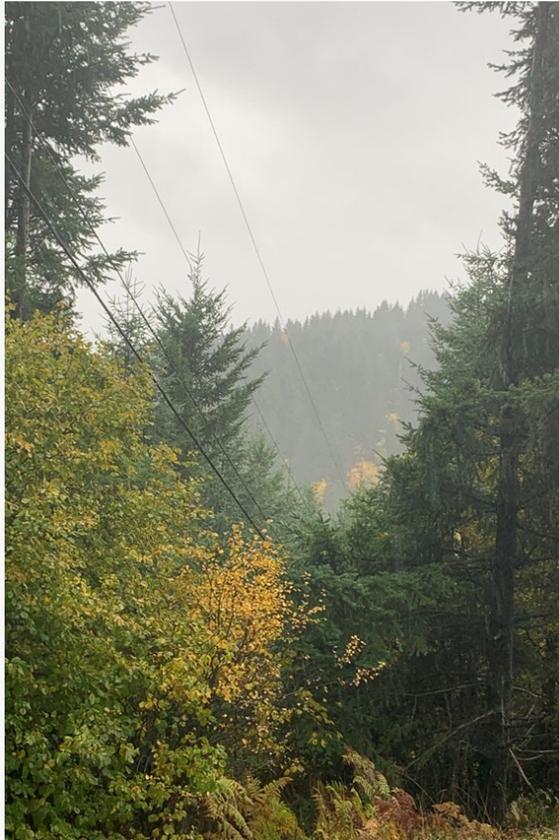
FSPM: Before

During patrol, small diameter, suppressed firs were targeted for removal; pruning prescribed to target overhang and encroaching growth; and mowing to mitigate the dense undergrowth of fast-growing maples and other infill.

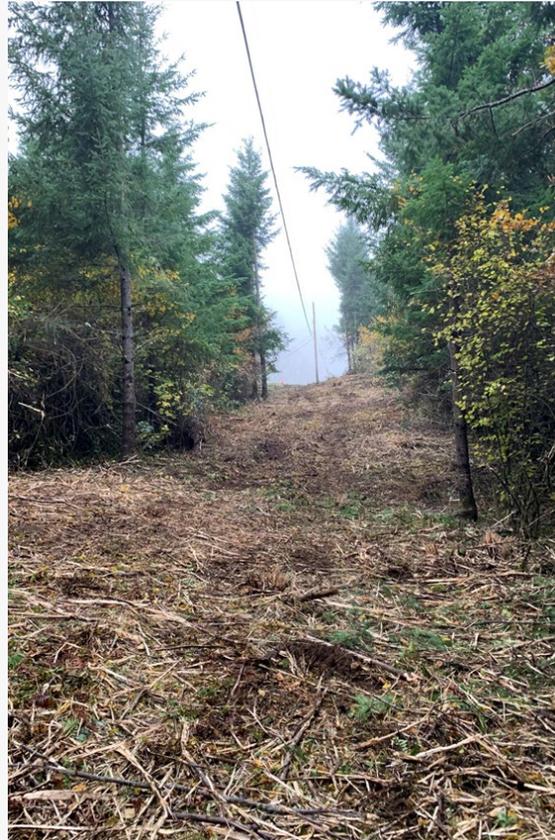
FSPM: After

After implementing mitigation measures, the corridor is now accessible, visible, and has reduced ignition and outage risks.

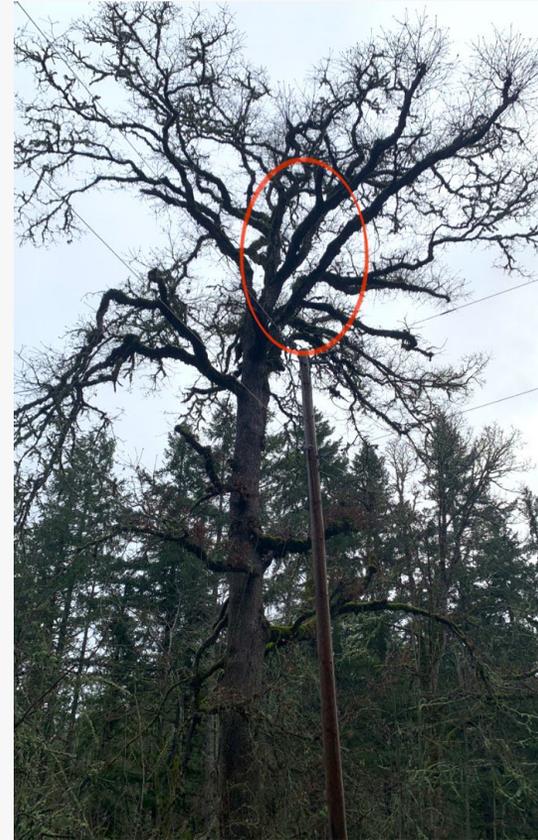
FSPM: Before

C2 Pruning
During patrol, structural defects were found in the overhang of an Oregon white oak.

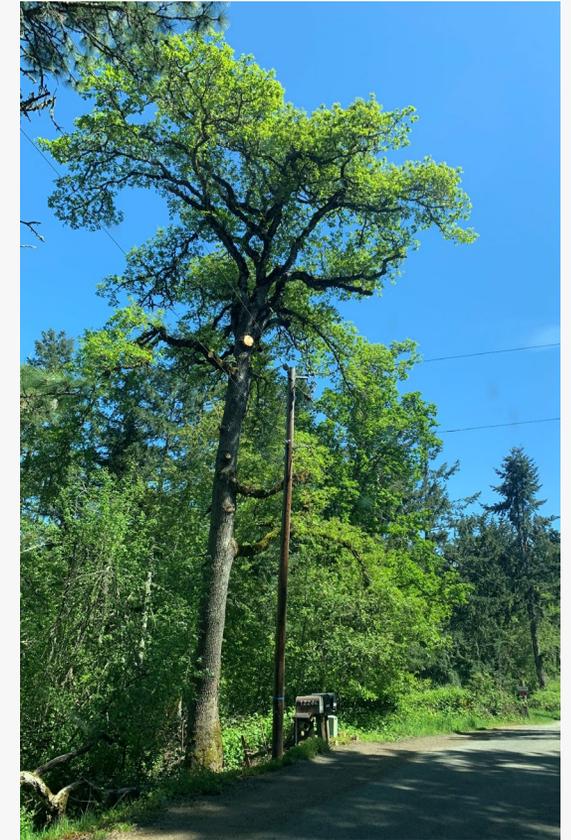
FSPM: After

C2 Pruning
A tree crew was tasked with pruning and removing targeted limbs to reduce the risk of failure.

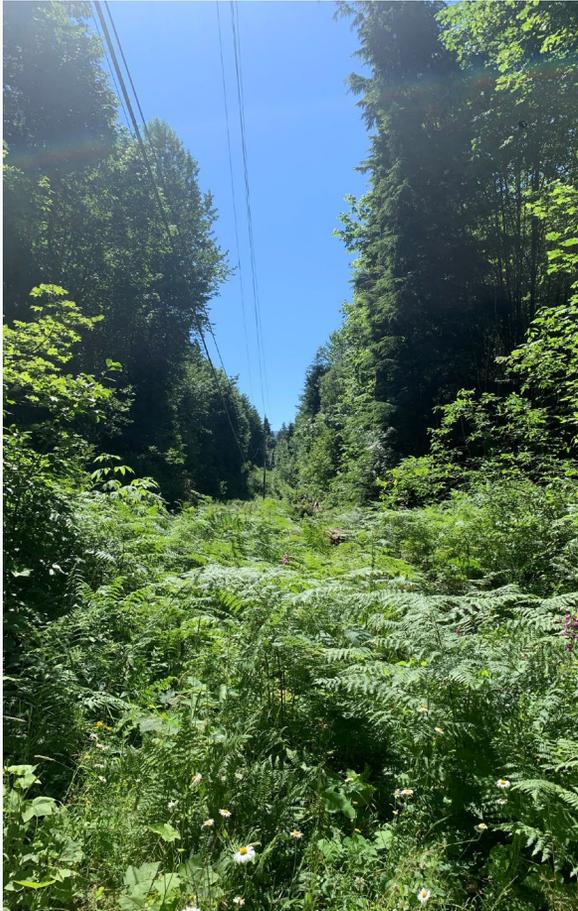
FSPM: Before

Through coordination with the USFS, this densely vegetated corridor within the Mount Hood National Forest was prescribed mowing along with C2 pruning and removal.

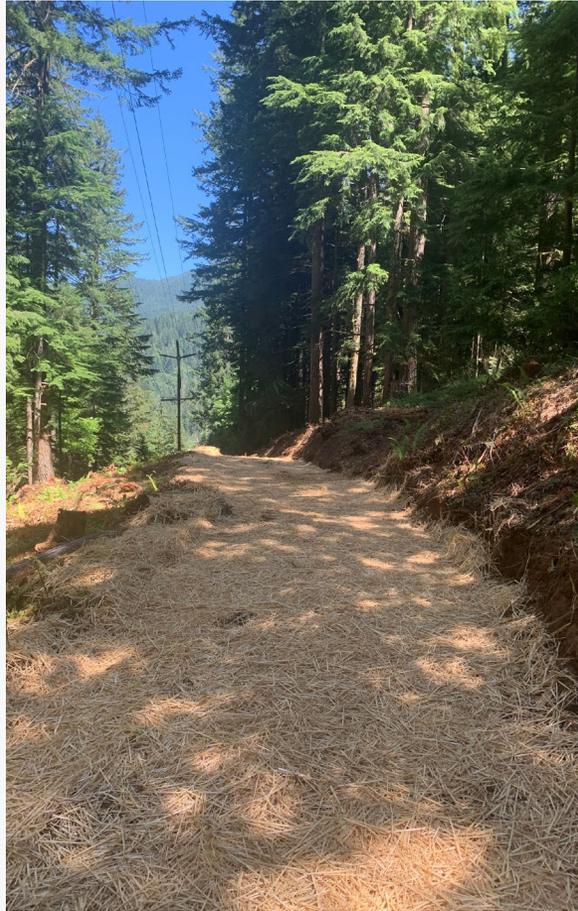
FSPM: After

C2 vegetation along with infill removal reduces the risk of contact with conductors while expanding the corridor and opening up access and visibility for utility patrol and operations in the future.

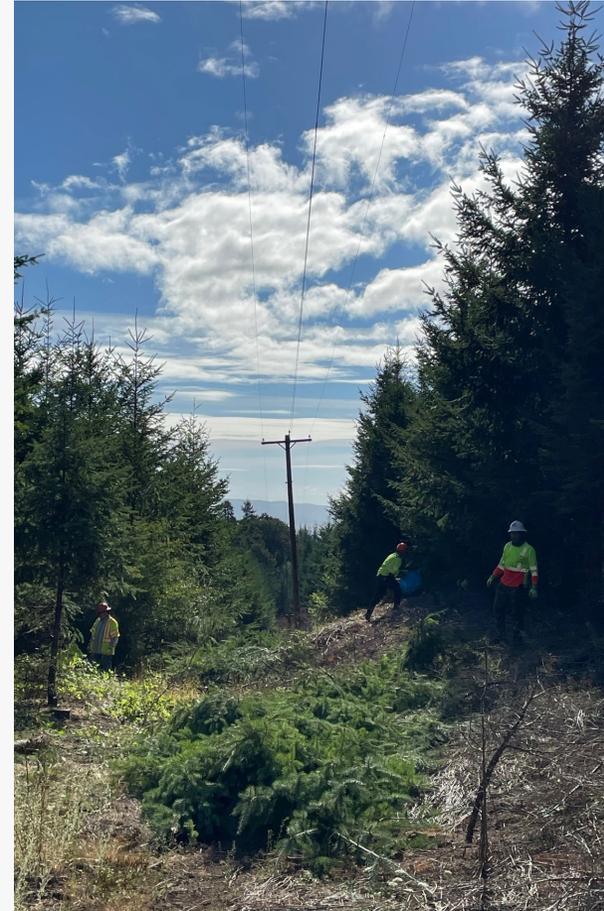
FSPM: Before

Working with the property owner, AWRR targeted removal of small firs growing under the conductor and undesirable firs adjacent to the right-of-way, opening up the corridor and delivering long-term results.

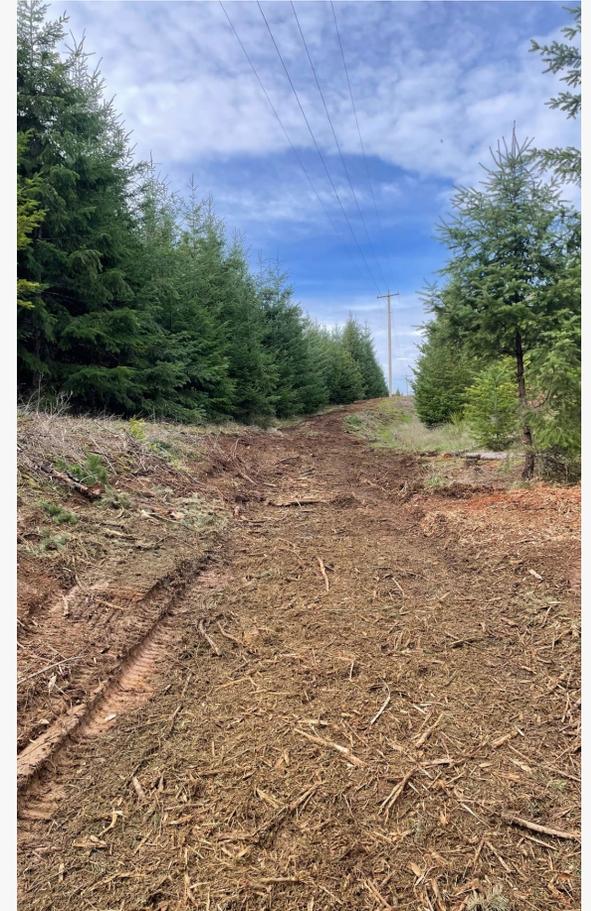
FSPM: After

After the mitigation process, a mower masticated the remaining fir limbs and small-diameter infill. This not only works toward long-term results but also improves access and visibility.

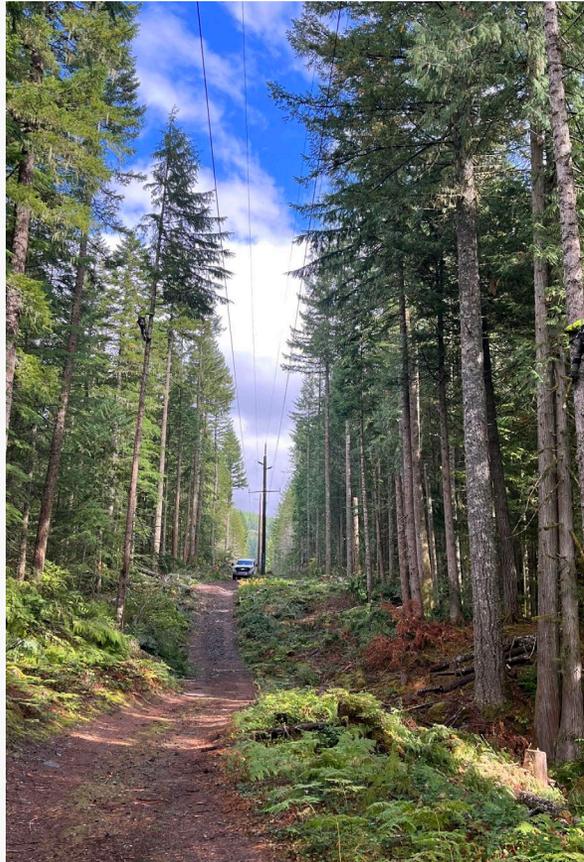
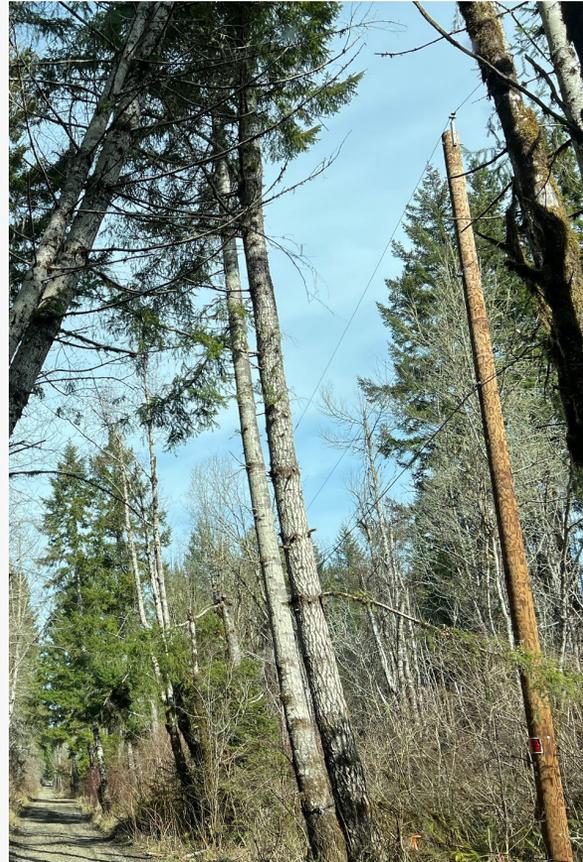
Before

A densely vegetated area in Grand Ronde along Alvord Alley in Zone 10, populated by faster-growing fir, ash, willow, cottonwood, and alder, is prescribed both C2 removals and mowing as mitigation strategies.

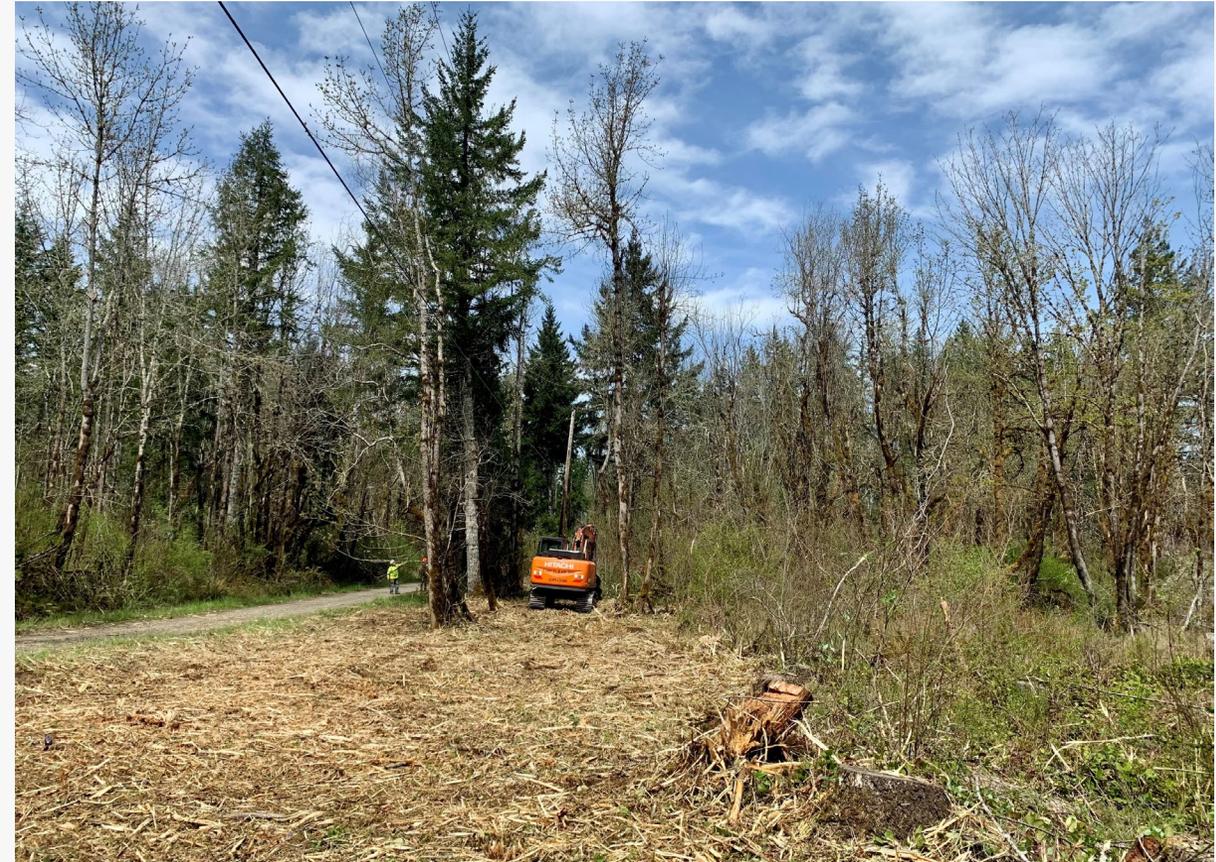
C2 Removal + Mowing: After

The risk of vegetation contact with the conductor was reduced by removing fast-growing C2 vegetation using a fuel reduction strategy. A Slashbuster was used to clear the infill efficiently. Foresters will keep monitoring the area for C1/C2 vegetation and the emergence of fast-growing infill, treating it during the next patrol and mitigation period.
